MISCELLANEOUS PAPER S-72-19

CONDITION SURVEY, CAMPBELL ARMY AIRFIELD, FORT CAMPBELL, KENTUCKY

P. J. Vedros, S. J. Alford

June 1972

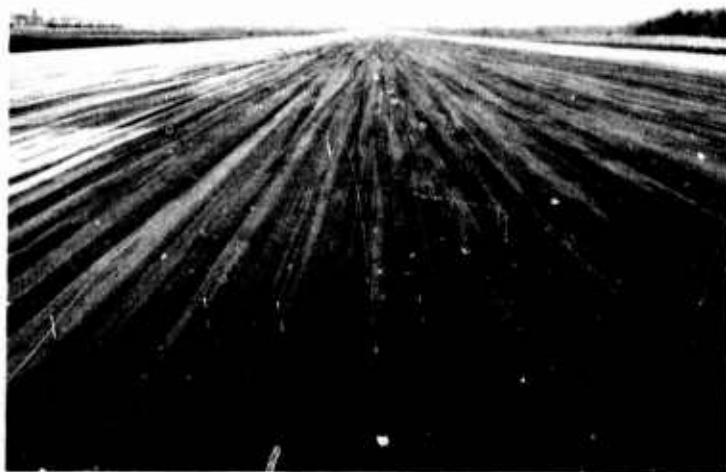
Photograph 2. General view of asphaltic
concrete along NE-SW runway

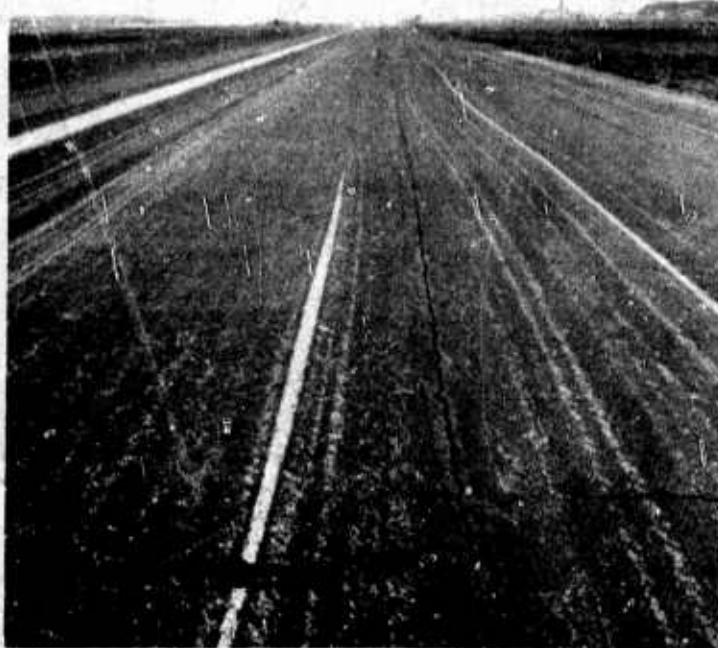
the surface. These areas will be patched with an epoxy grout in the near future. A general view of the asphaltic concrete portion of the runway is shown in photograph 2. The surface condition along the parallel taxiway indicated more cracking and longitudinal joint opening (photographs 3 and 4) than observed on the runway. The runway and taxiways 2 and 5 were overlaid in 1967, and the pavement surface is in better condition than the other facilities that had not been overlaid, as can be seen by comparison of photograph 2 with photographs 3 and 4. The pavement surface on runways 18-36 (north-south) and 14-32 (northwest-southeast) and taxiways D, F, and J was generally in fair to poor condition. The pavements were constructed in 1942-43 and appear to be very dead and dried out. Failures had occurred in a marked-off landing area on runway 18-36, which was being used by C-130 aircraft. Photographs 5-7 indicate the condition of these pavements and types of failures. Future plans consist of building helicopter hangars adjacent to the east side of runway 14-32 and north side of taxiway F, and these facilities will be overlaid or strengthened at that time. The PCC hardstands were in excellent condition. The PCC apron (designated southwest parking apron, plate 1) was in good condition with less than 3 percent of the slabs containing structural defects (photograph 8). There were one or two areas near drainage catch basins where the slabs were tilted. The Alpha and Charlie parking aprons were in fair condition. The pavements had numerous shrinkage cracks and openings at the joints, as shown in photographs 9 and 10.

Photograph 3. Longitudinal joint opening and shrinkage cracking in parallel taxiway

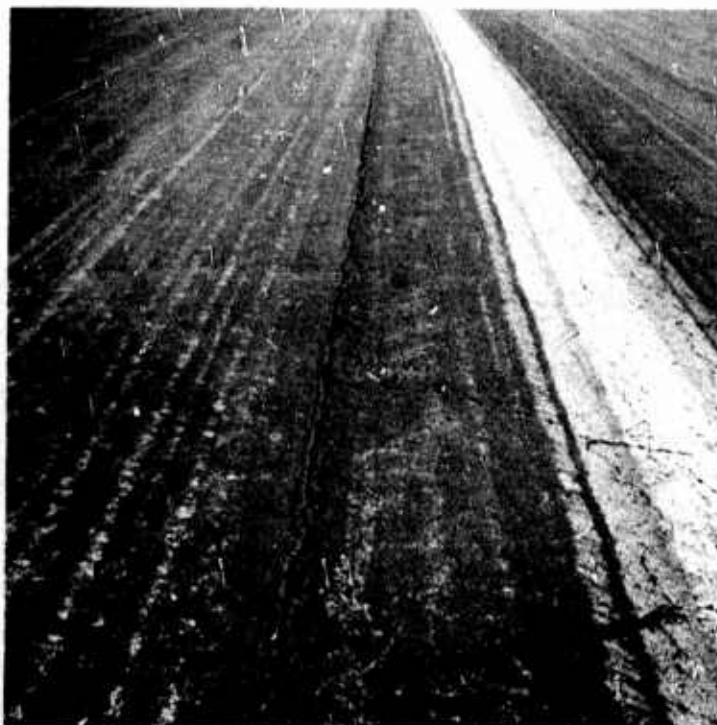
Photograph 4. General condition of surface of pavement that was not overlaid in 1967

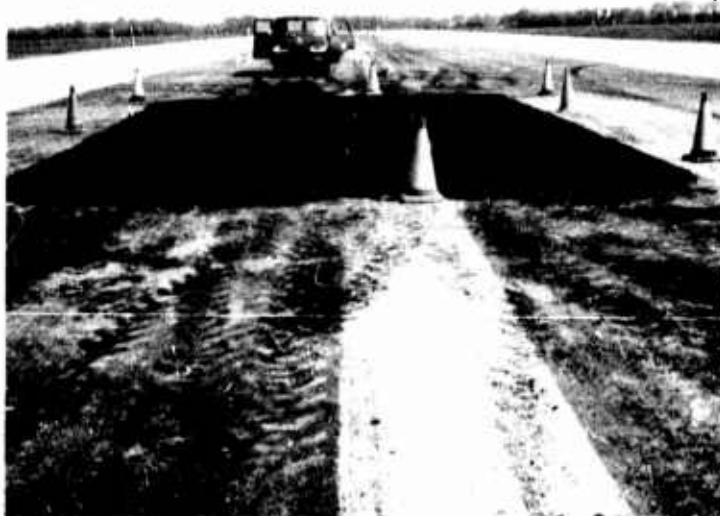
14. Detailed traffic records were not available. The airfield pavements were originally designed for and used by all types of Air Force aircraft; even though the airfield has been transferred to the Army, the field is still used by all types of Air Force aircraft. It was reported that the facilities receive normal use by light Army aircraft and considerable traffic from transient aircraft, such as heavy cargo and fighter planes. For the past two years, C-130 aircraft from another airbase have been using the airfield for training exercises. This has consisted of five-days-a-week operations of practicing assault and touch-and-go landings. The assault landings have been made on runway 18-36, and at the time of this survey, failures were occurring in the pavement surface from this type operation.

Photograph 6. Area on runway 18-36 that was
patched after failure from C-130 operations
